DEVELOPMENT OF THE ULTRASONIC DELTA TECHNIQUE FOR  
ALUMINUM WELDS AND MATERIALS

K. J. Hannah, B. T. Cross and  
W. M. Tooley

Final Report No. 68-25

Prepared under Contract No. NAS 8-18009 by  
AUTOMATION INDUSTRIES, INC.  
Boulder, Colorado

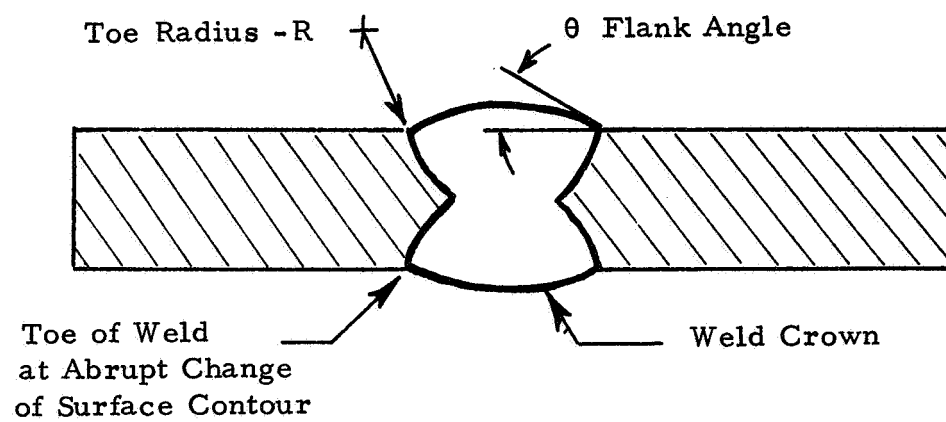
Figure No. 11

The level of the noise was directly proportional to the flank angle and indirectly proportional to the toe radius. An abrupt surface change presented an interface to the transmitted shear beam and the result was a defect type ultrasonic indication.

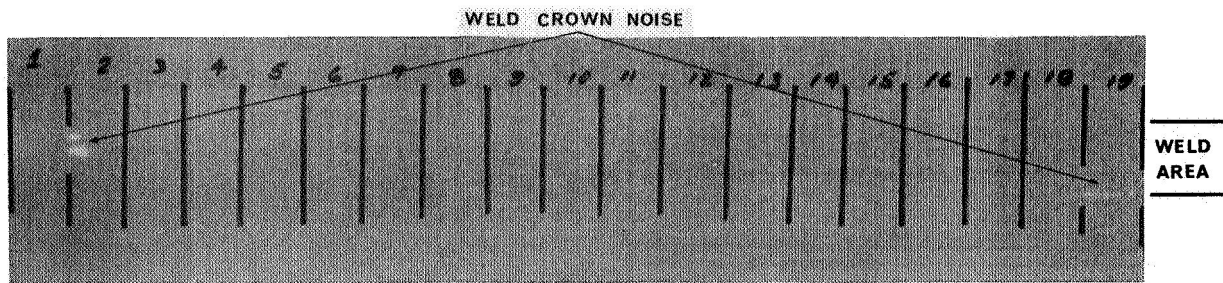
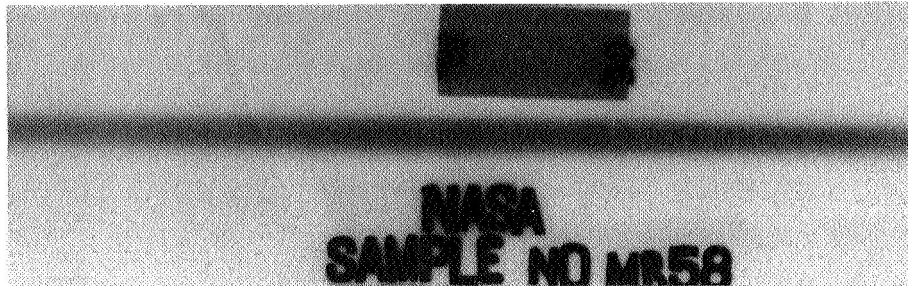
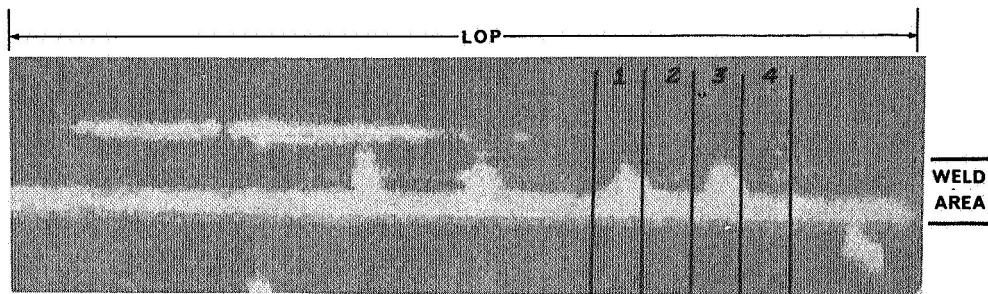
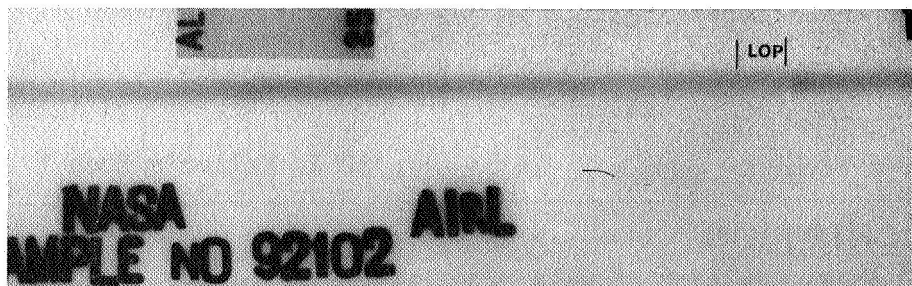
FIGURE NO. 13

The Basic Delta scan recording and the corresponding radiograph of weld panel MR 58 are shown in Figure No. 13A. This weld panel is the good weld example. Close correlation of the test results was achieved for the Delta and radiographic inspection techniques. Tests showed the weld to be free of defect indications. This weld panel was inspected in the as-welded condition. Two instances of weld crown noise were recorded on the Delta scan recording for panel MR 58. These noise indications are identified in Figure No. 13A. Destructive analysis proved the weld to be free of defects.

The Delta scan and radiograph of panel 92102 in the as-welded condition, containing a tight lack of penetration condition, are shown in Figure No. 13B. This Delta recording indicated a defect condition along the entire length of the weldment; however, only one line type defect indication was detected in the radiograph. The radiographic indication was interpreted as lack of penetration in sections No. 2 and 3; no other LOP indications were noted on the radiograph. Weld crown noise was recorded along the outside edge of the weld zone, but such indications had no significance when the weld was evaluated in the as-welded condition. No weld blending tests were made on panel 92102 prior to destructive analysis.

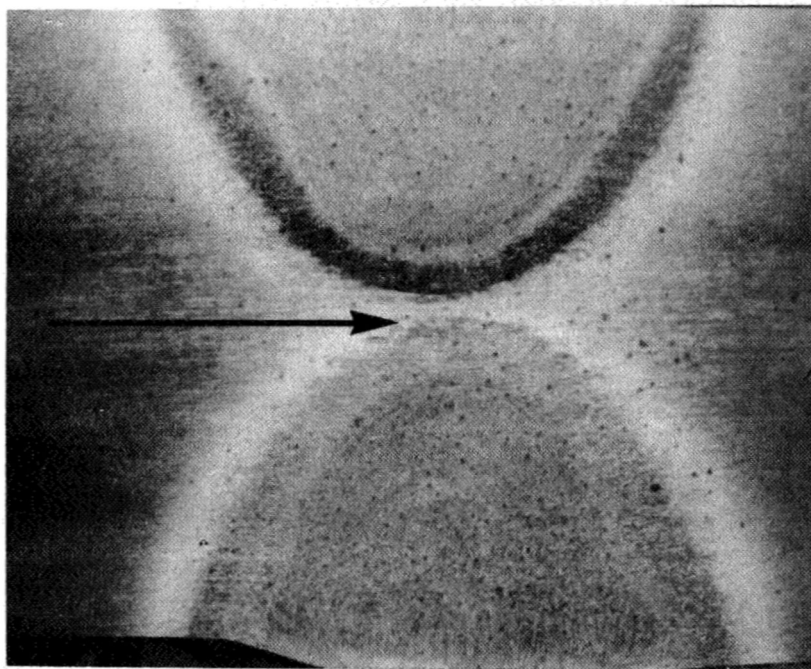
Figure No. 15

Four metallurgical sections were removed from panel 92102 and the lack of penetration condition was confirmed for all sections. Micro and macro-photographs of the defect condition are shown in Figures No. 14 and 15. (Images in the micro-photos are reversed because of the camera-microscope optic system.) These photographs show a tight lack of penetration with a vertical width of approximately 0.070 inches. This LOP condition was continuous through all metallurgical sections of this 7/16" thick weldment.

The above macrograph illustrates a 7X enlargement of a lack of weld penetration condition which existed in sample no. 4.

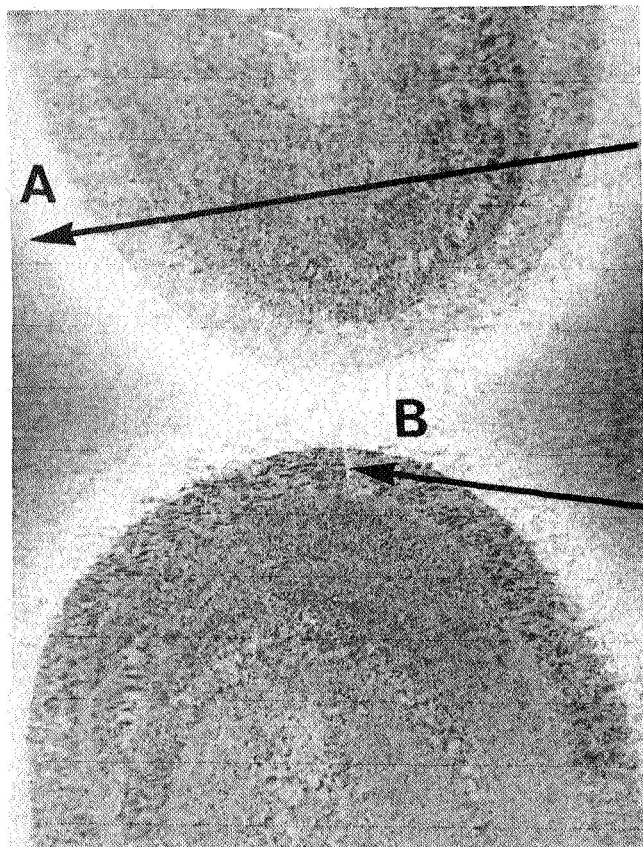
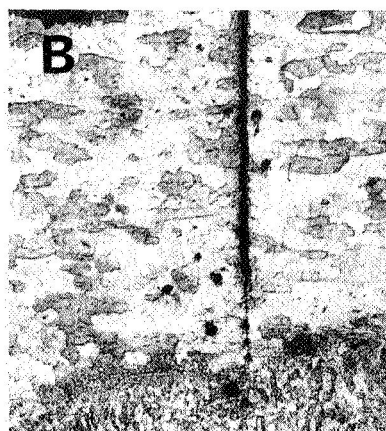
PLATE NO. 92107  
SECTION NO. 2/1-0  
CUT NO. Face cut

Another example of LOP detected with the Basic Delta Technique is illustrated in Figure No. 16. Weld panel 92107, 1.0 inch thick was radiographed and the LOP condition was not detected. The Delta scan clearly shows the defect condition on the right side of the weld sample (see Figure No. 16). In Section No. 3, the LOP indication was reduced in size, but the indication was still evident. This LOP condition was located in all three metallurgical specimens, one of which is shown in Figure No. 17. Both edges of the unfused weld joint are in intimate contact, a most difficult flaw condition to consistently detect by radiographic examination.

Micrograph A shows an inclusion particle found in the base metal adjacent to the weld area. Micrograph B and the macrograph depict the lack of weld penetration condition in Sample No. 2.

The vertical width of the LOP condition was approximately 0.160 inches and the defect was continuous along the weldment examined.

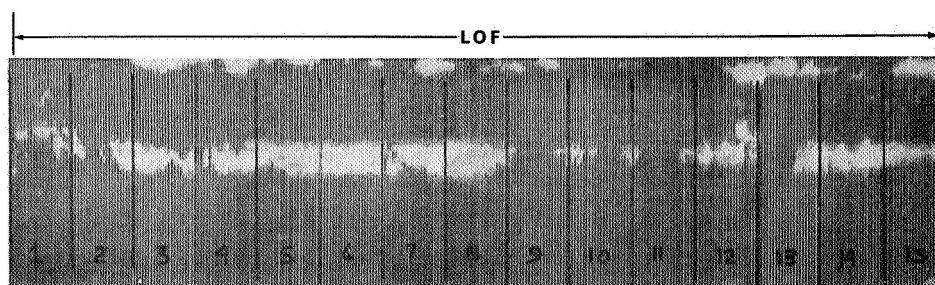
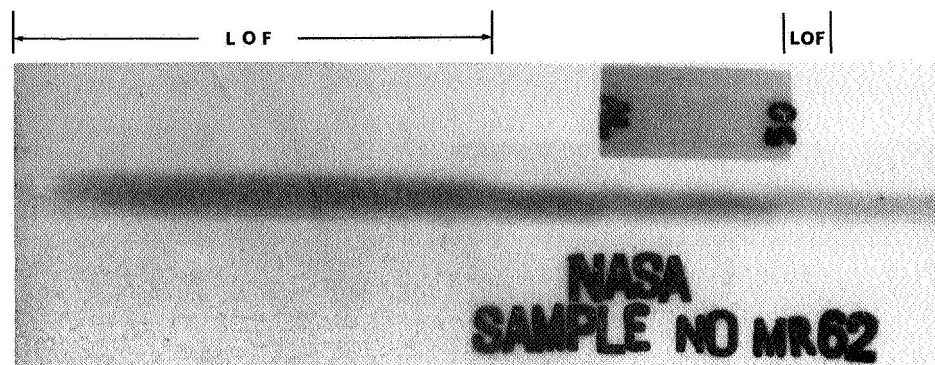
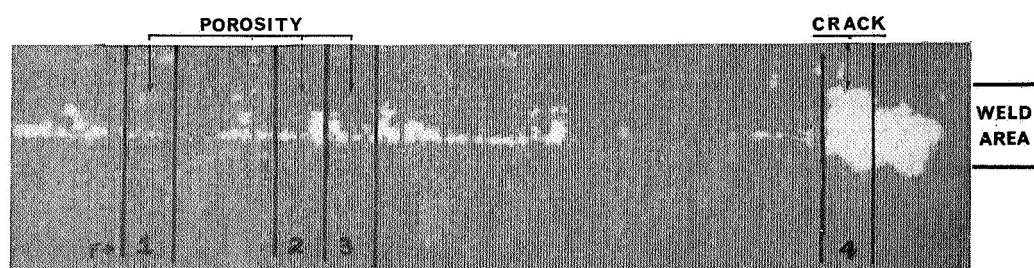
FIGURE NO. 18

Figure No. 18 shows the Delta recording and radiograph of weld panel MR 62 (a 1/2" thick weldment). Both the Delta scan and the radiograph contained full length flaw indications. Destructive analysis of the entire panel revealed a gross lack of fusion (LOF) distributed throughout the weld. These defect conditions are shown in Figures No. 19, 20, and 21. The LOF condition occurred at the edge of the joint between the base metal and the weld deposit. This condition is shown in micrograph B of Figure No. 19. The vertically oriented defect was detected with both Basic Delta and radiographic techniques; however, the second LOF condition was detected with the Delta Technique, only. LOF occurred in the center of the upper weld joint between the bottom of the bead and base metal. See micrograph A in Figure No. 19. This type of LOF was not detected with radiography because the interface lay perpendicular to the X-Ray beam. Figures No. 20 and 21 show additional examples of LOF found in other metallurgical samples from the same weldment. Metallurgical examinations indicated that the LOF conditions in panel MR 62 ranged in size from 0.010 inches to 0.130 inches in width and extended throughout the total length of weldment.

Porosity and intergranular cracking were detected in weld panel 2610000 with the basic Delta Technique. Porosity indications are visible on the Delta recording shown in Figure No. 18. The large indication at the right edge of the Delta scan represented a 0.250 inch long vertical intergranular crack. This was the most significant cracking condition located during the destructive analysis in this study program. (See Figure No. 24) Isolated porosity greater than 0.010 inch diameter and chain porosity smaller than 0.010 inch diameter (micro-porosity) were the major types of porosity found in these aluminum welds. Large bits of isolated porosity occurred in the center region of the welds and were readily detected with both the basic Delta and the radiographic techniques. Micro-porosity (less than 0.010 inch diameter) occurred in the majority of the weld panels, that were sectioned for metallurgical analysis. The existence of microporosity was not clearly determined by either radiographic nor the basic Delta Techniques.

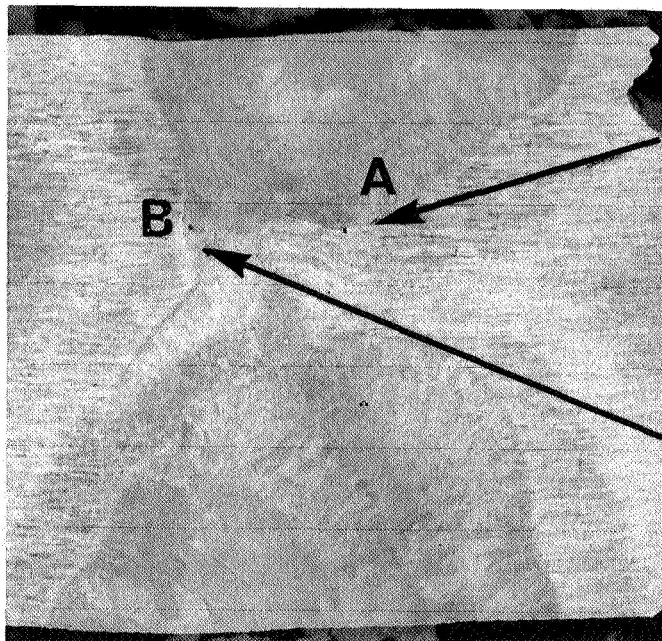
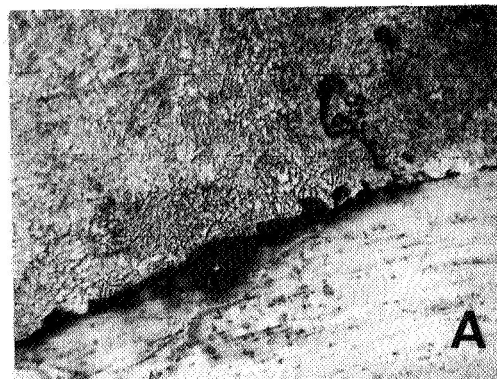
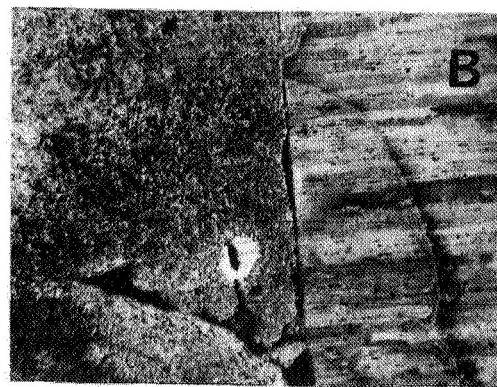
Figure No. 19

Lack of Fusion Condition

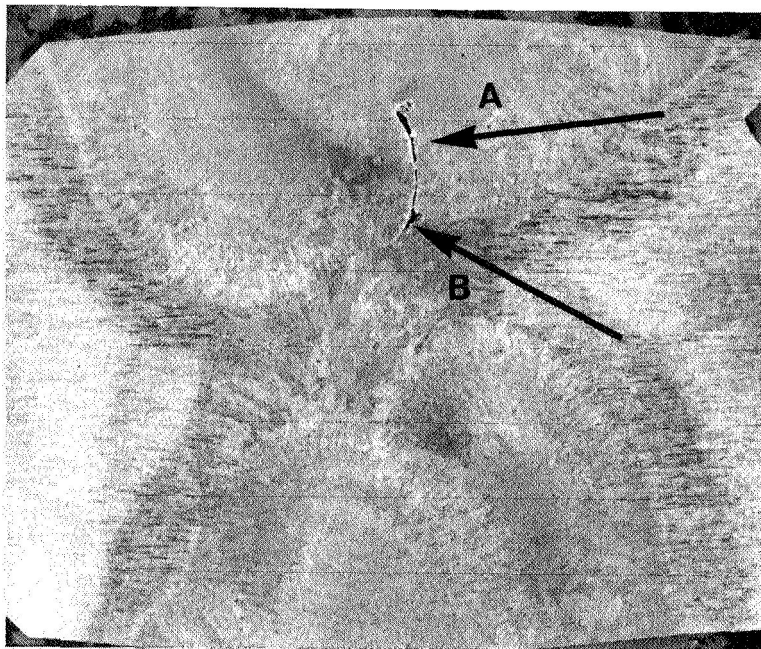
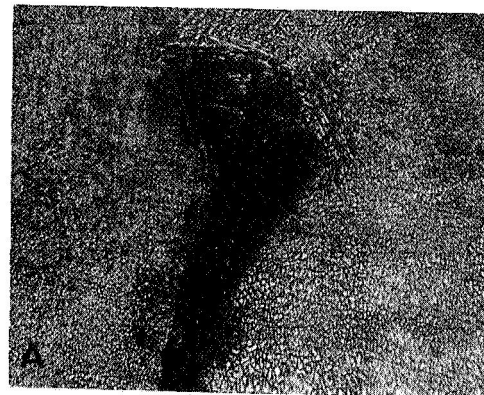
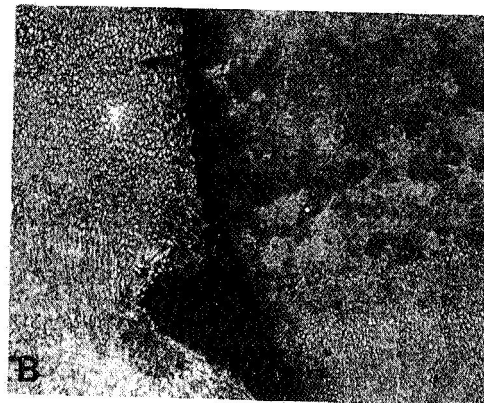
Figure No. 20

Lack of Fusion Condition

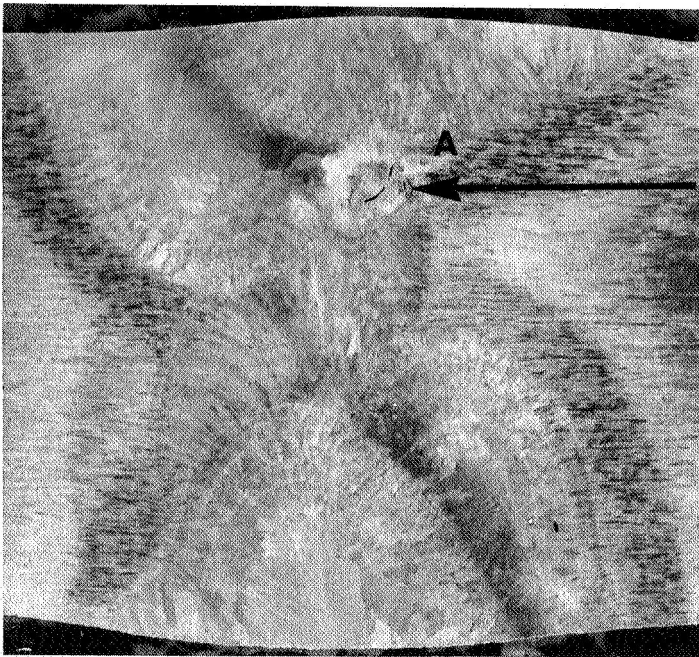
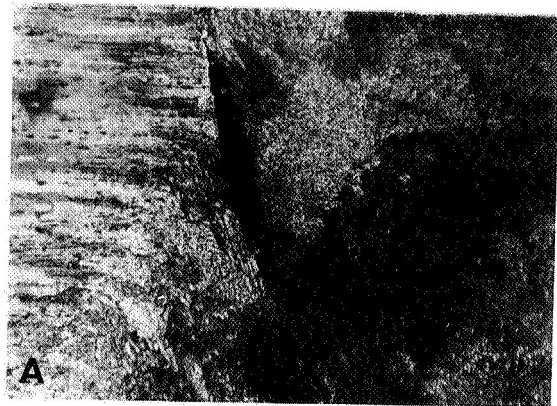
**PLATE NO. MR 62**  
**SECTION NO. 15 / 1-2**  
**CUT NO. Face**

A - Lack of Fusion Condition

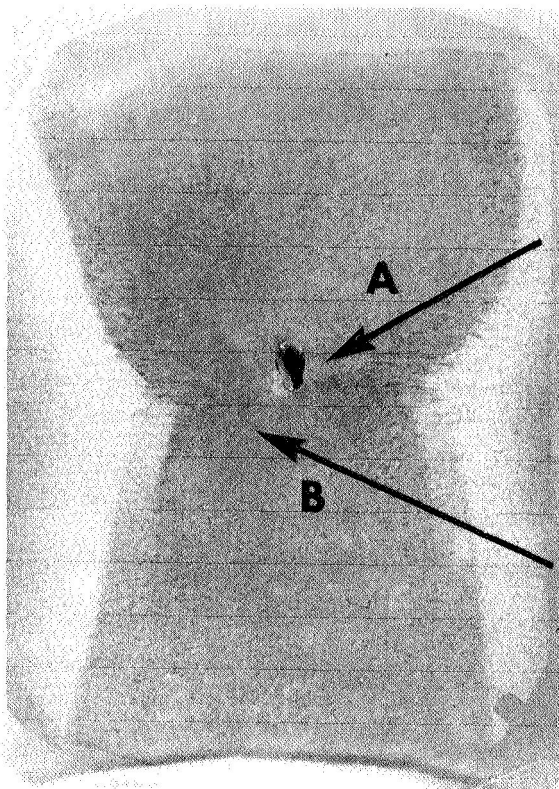
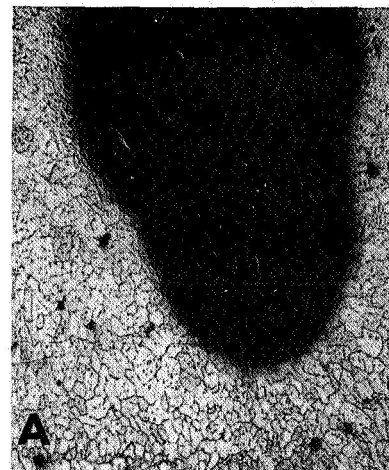
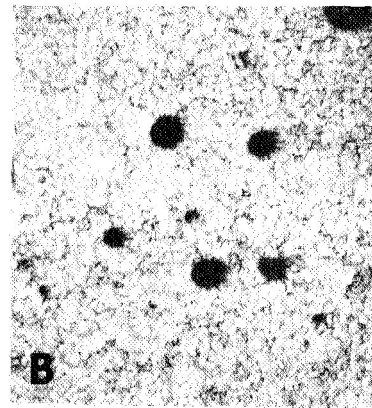
Figure No. 22

Photographs of isolated porosity, approximately 0.060 inches in diameter are illustrated in Figures No. 22 and 23. An example of micro-porosity located at the edge of the fusion zone is shown in micrograph A in Figure No. 24. In some instances this micro-porosity condition was associated with a porosity-like condition in the adjacent aluminum base metal.

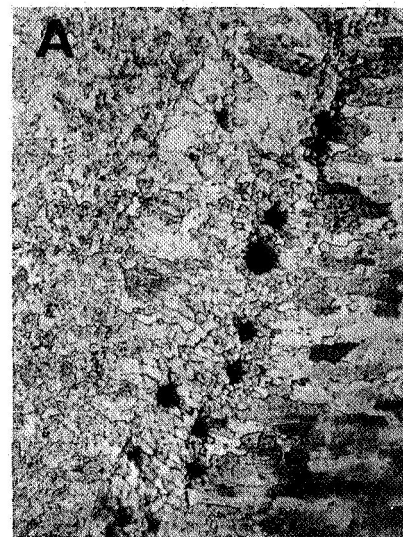
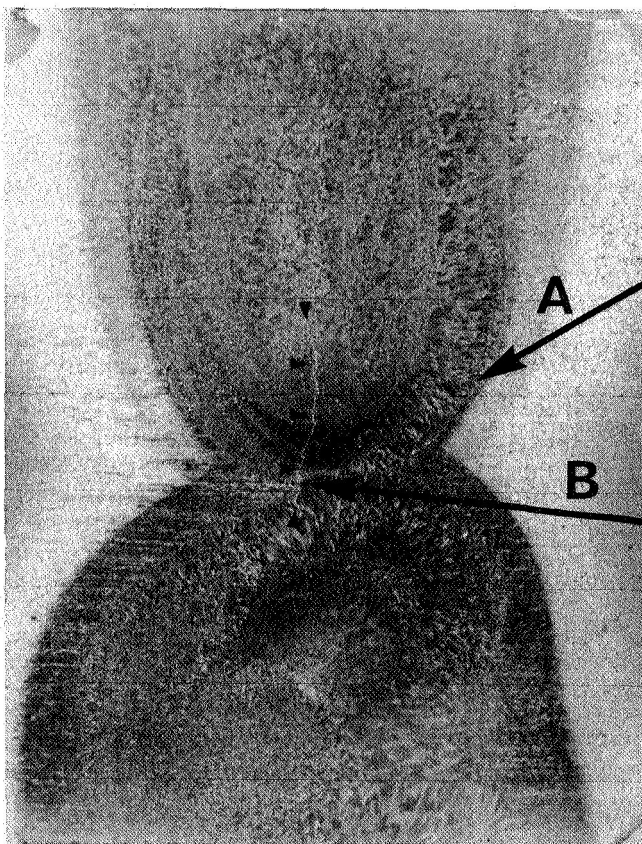
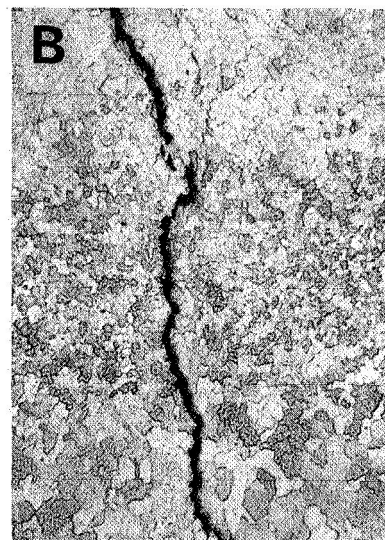
PLATE NO. 2610000  
SECTION NO. 4/2-3  
CUT NO. 9

The above macrograph illustrates an intergranular cracking condition in the root area of the weld. An enlarged view of the  $\frac{1}{4}$  inch long crack is shown in micrograph B. Chain porosity was noted along the weld fusion zone. Micrograph A illustrates a typical condition.

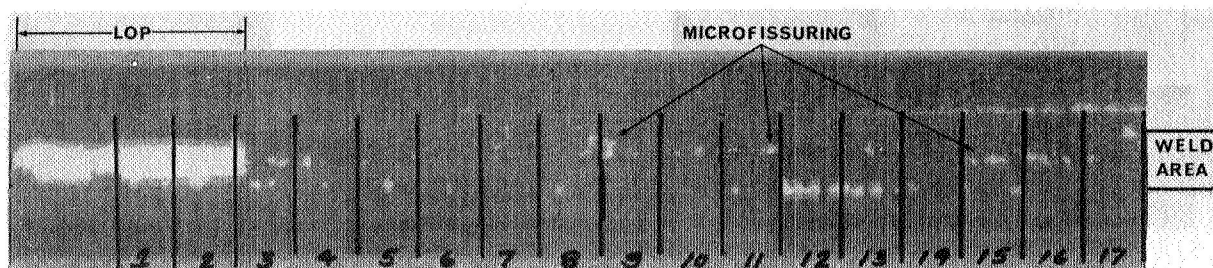
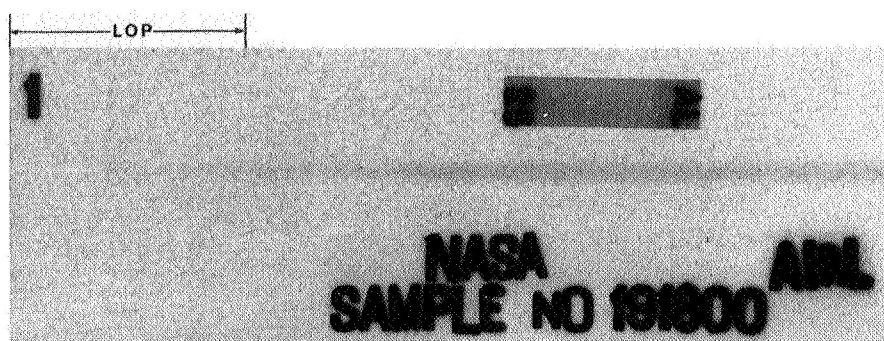
FIGURE NO. 25

Figure 25 shows the Delta recording and the radiograph of weld panel 191800 which contained LOP and microfissuring. The LOP condition was clearly

indicated at the left edge in both the radiograph and the Delta scan. However, the microfissuring condition shown in Figures No. 26 and 27 was detected only by the Delta Technique. Microfissuring, a shrinkage phenomena that occurred in 3/16" and 1/4" weldments, was oriented parallel to the surface of the weld panels. Defects with this orientation are not readily detected with radiography. The Delta scan recording clearly shows defect indications along the length of the weldment. Destructive analysis of the entire weldment revealed a microfissuring condition near the surface of the weld crown as shown in Figures No. 26 and 27.

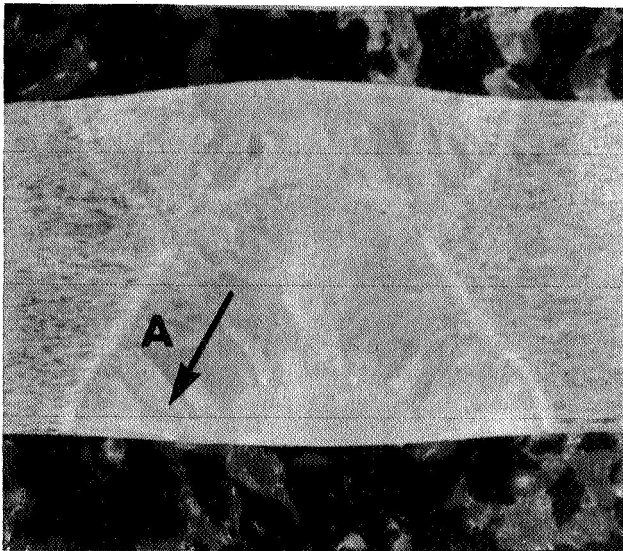
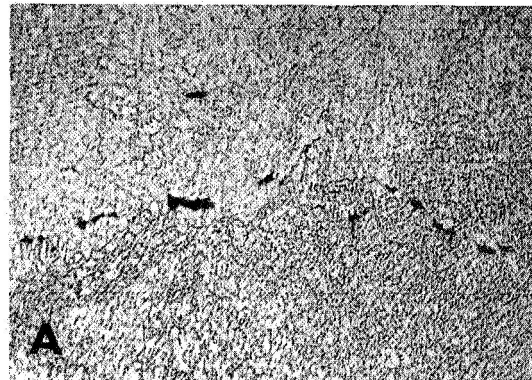
Figure No. 26

Micrograph A - Micro-fissure

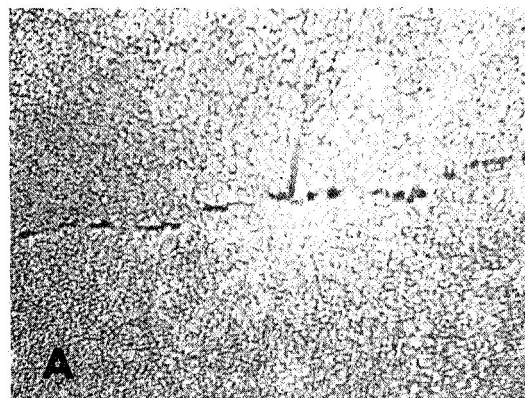
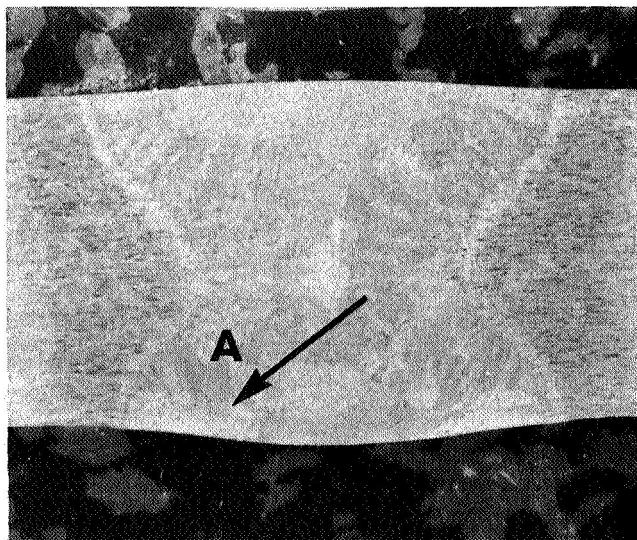
**PLATE NO. 191800**  
**SECTION NO. 9/1-2**  
**CUT NO. 2**

Micrograph A - Micro-fissure
